DTIC FILE COPY
AUTOMATED IMAGING SYSTEM
FOR BRIDGE INSPECTION

Report No.
FHWA/RD-87/090

Final Report
March 1988

6. Performing Organization Code	
7. Author(s) Joseph W. Brophy		8. Performing Organization Report No.	
9. Performing Organization Name and Address Sigma Research, Inc. 8710 148th Ave. NE Redmond, WA 98052		10. Work Unit No. (TRAIS) FCP 35L2-052

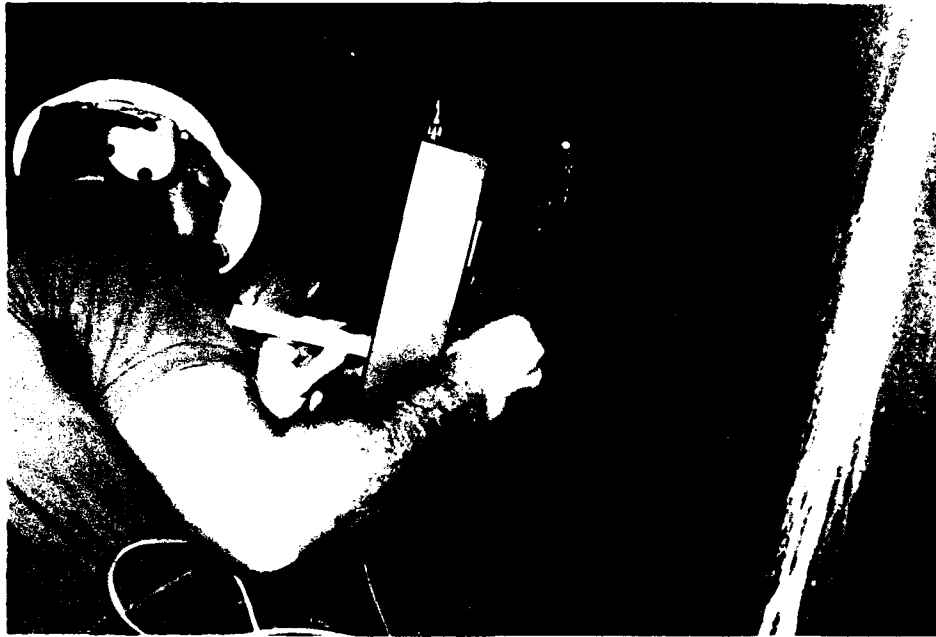
Figure 13. Inspection in the box girder. (a) Operator using the hand scanner to inspect near a web to girder wall fillet weld; (b) inspectors observing the ultrasonic A-scan signal on the downhole portable monitor.

The I-90 bridge structure is shown in figure 11. The main support structure consists of six steel box girders for each traffic direction. The entry hatch and inside structure of the girders are shown in figure 12. In figure 13, an operator is using the hand scanner to inspect a web to stiffener fillet weld. The "A-scan" data is being observed on the portable video monitor. Figure 14a shows the control van near the bridge. The 500-foot communication cable bundle is shown on its deployment spool and transport stand near the van. Figure 14b shows an operator at the uphole system control console. Both the uphole and downhole operators are wearing headsets for communication. The uphole system shown in this deployment trial differs from the final Phase III prototype shown in figure 1. This trial in early July of 1986 used the Intel 310 computer. No defects were expected or found during this test.

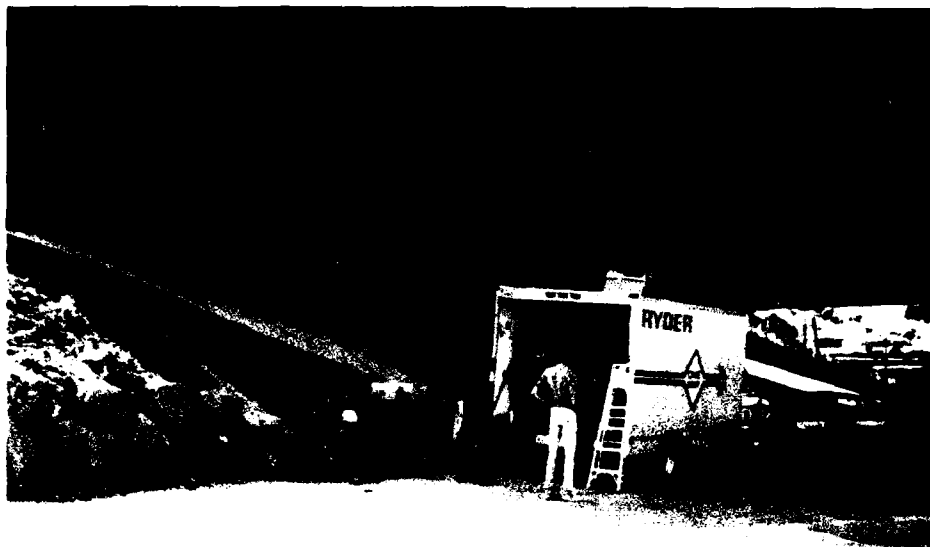
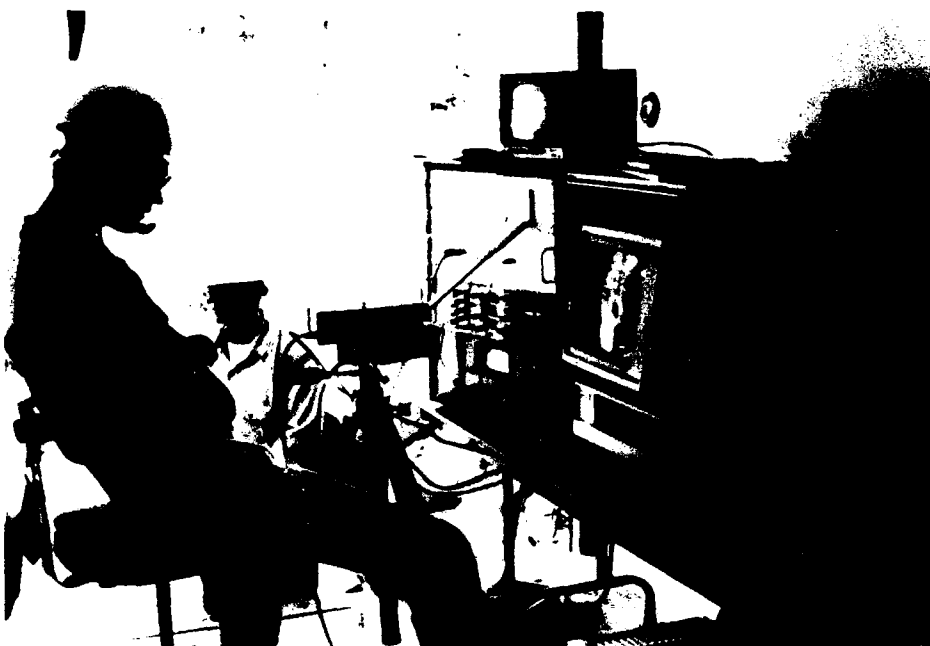
Figure 14. Uphole system. (a) Control van and communications cable; and (b) operator at the uphole system control console.
